**A STUDY OF THE USE OF VIBRATION AND STRESS WAVE  
SENSING FOR THE DETECTION OF BEARING FAILURE**

ENGINEERING REPORT NO. 75-18 C

National Aeronautics and Space Adminis-  
tration, George C. Marshall, Space Flight  
Center, Huntsville, Alabama 35812

ENDEVCO  
San Juan Capistrano  
30 September 75

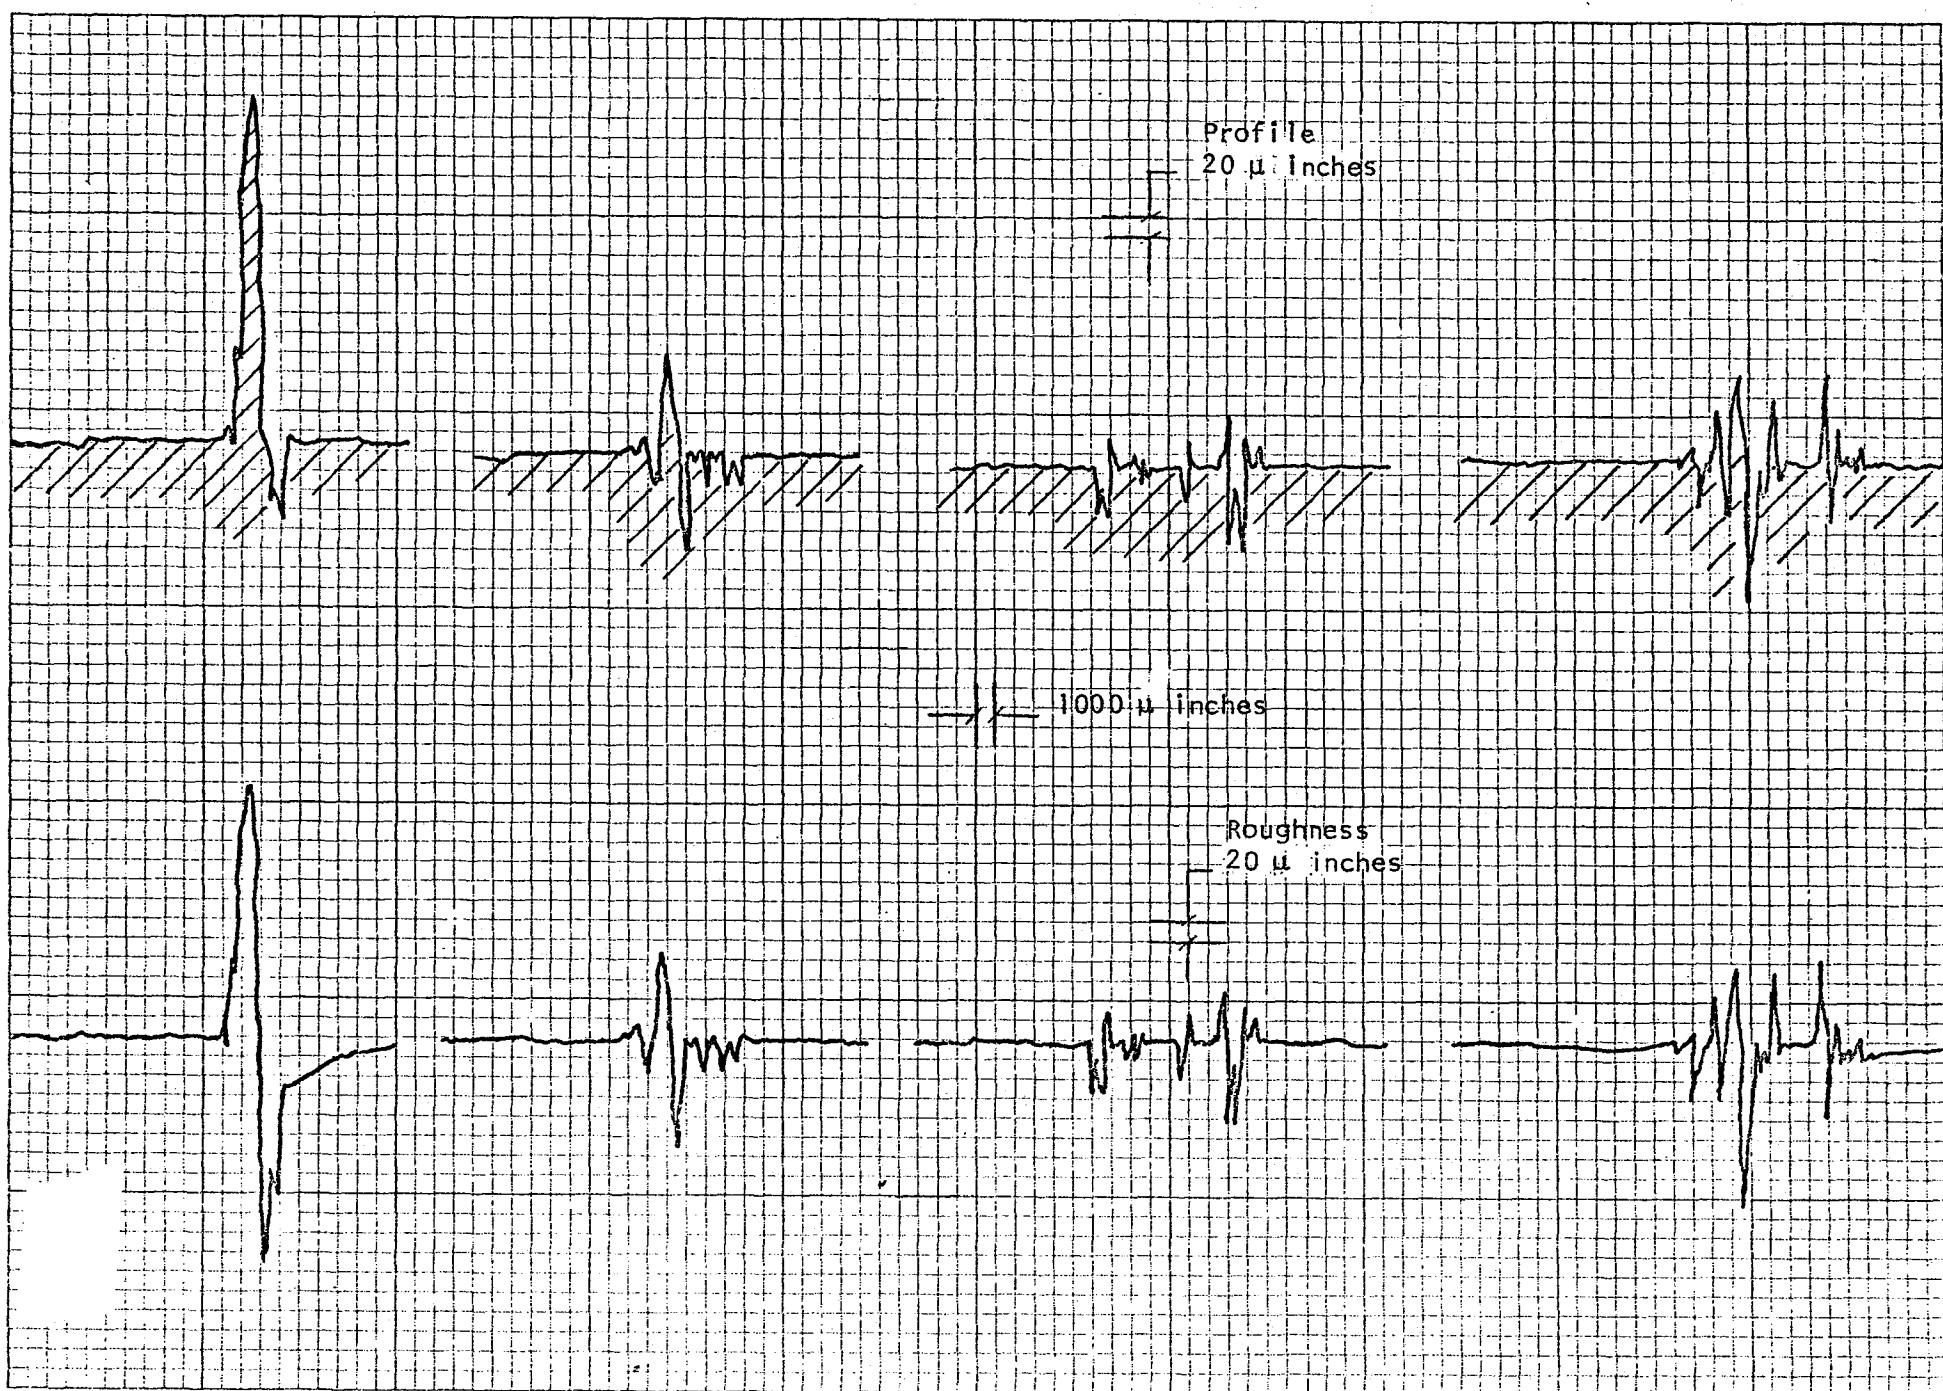
Figure 3-1b - Profilometer measurement of the faults scribed into one ball of bearing S/N 1.

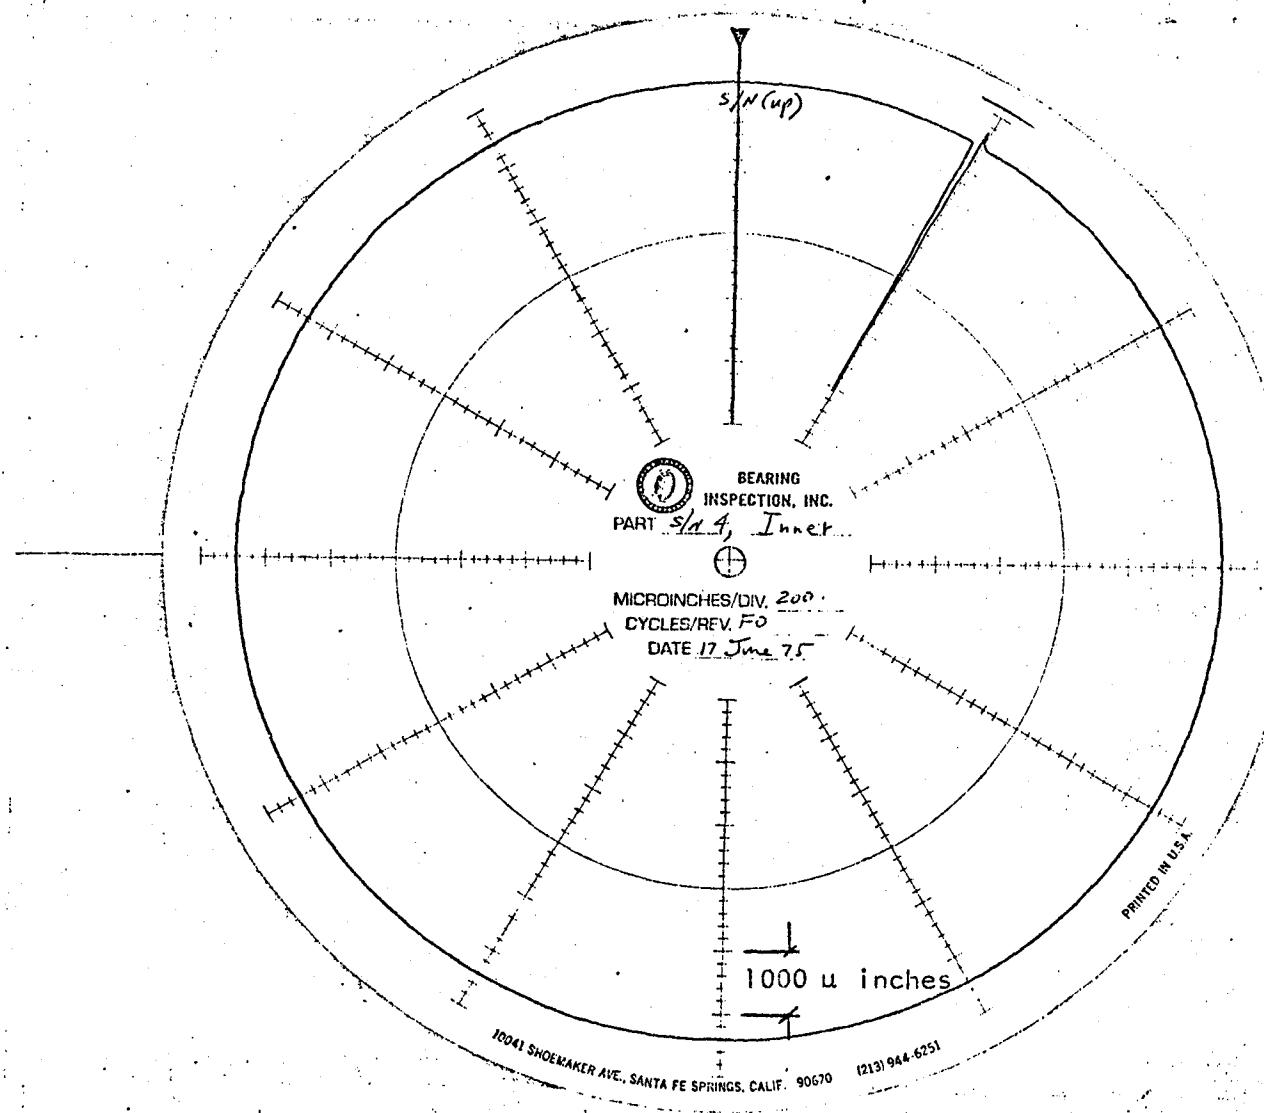
Figure 3-2a- Profilometer measurement of the fault location eloxed into the inner race of bearing S/N 4.

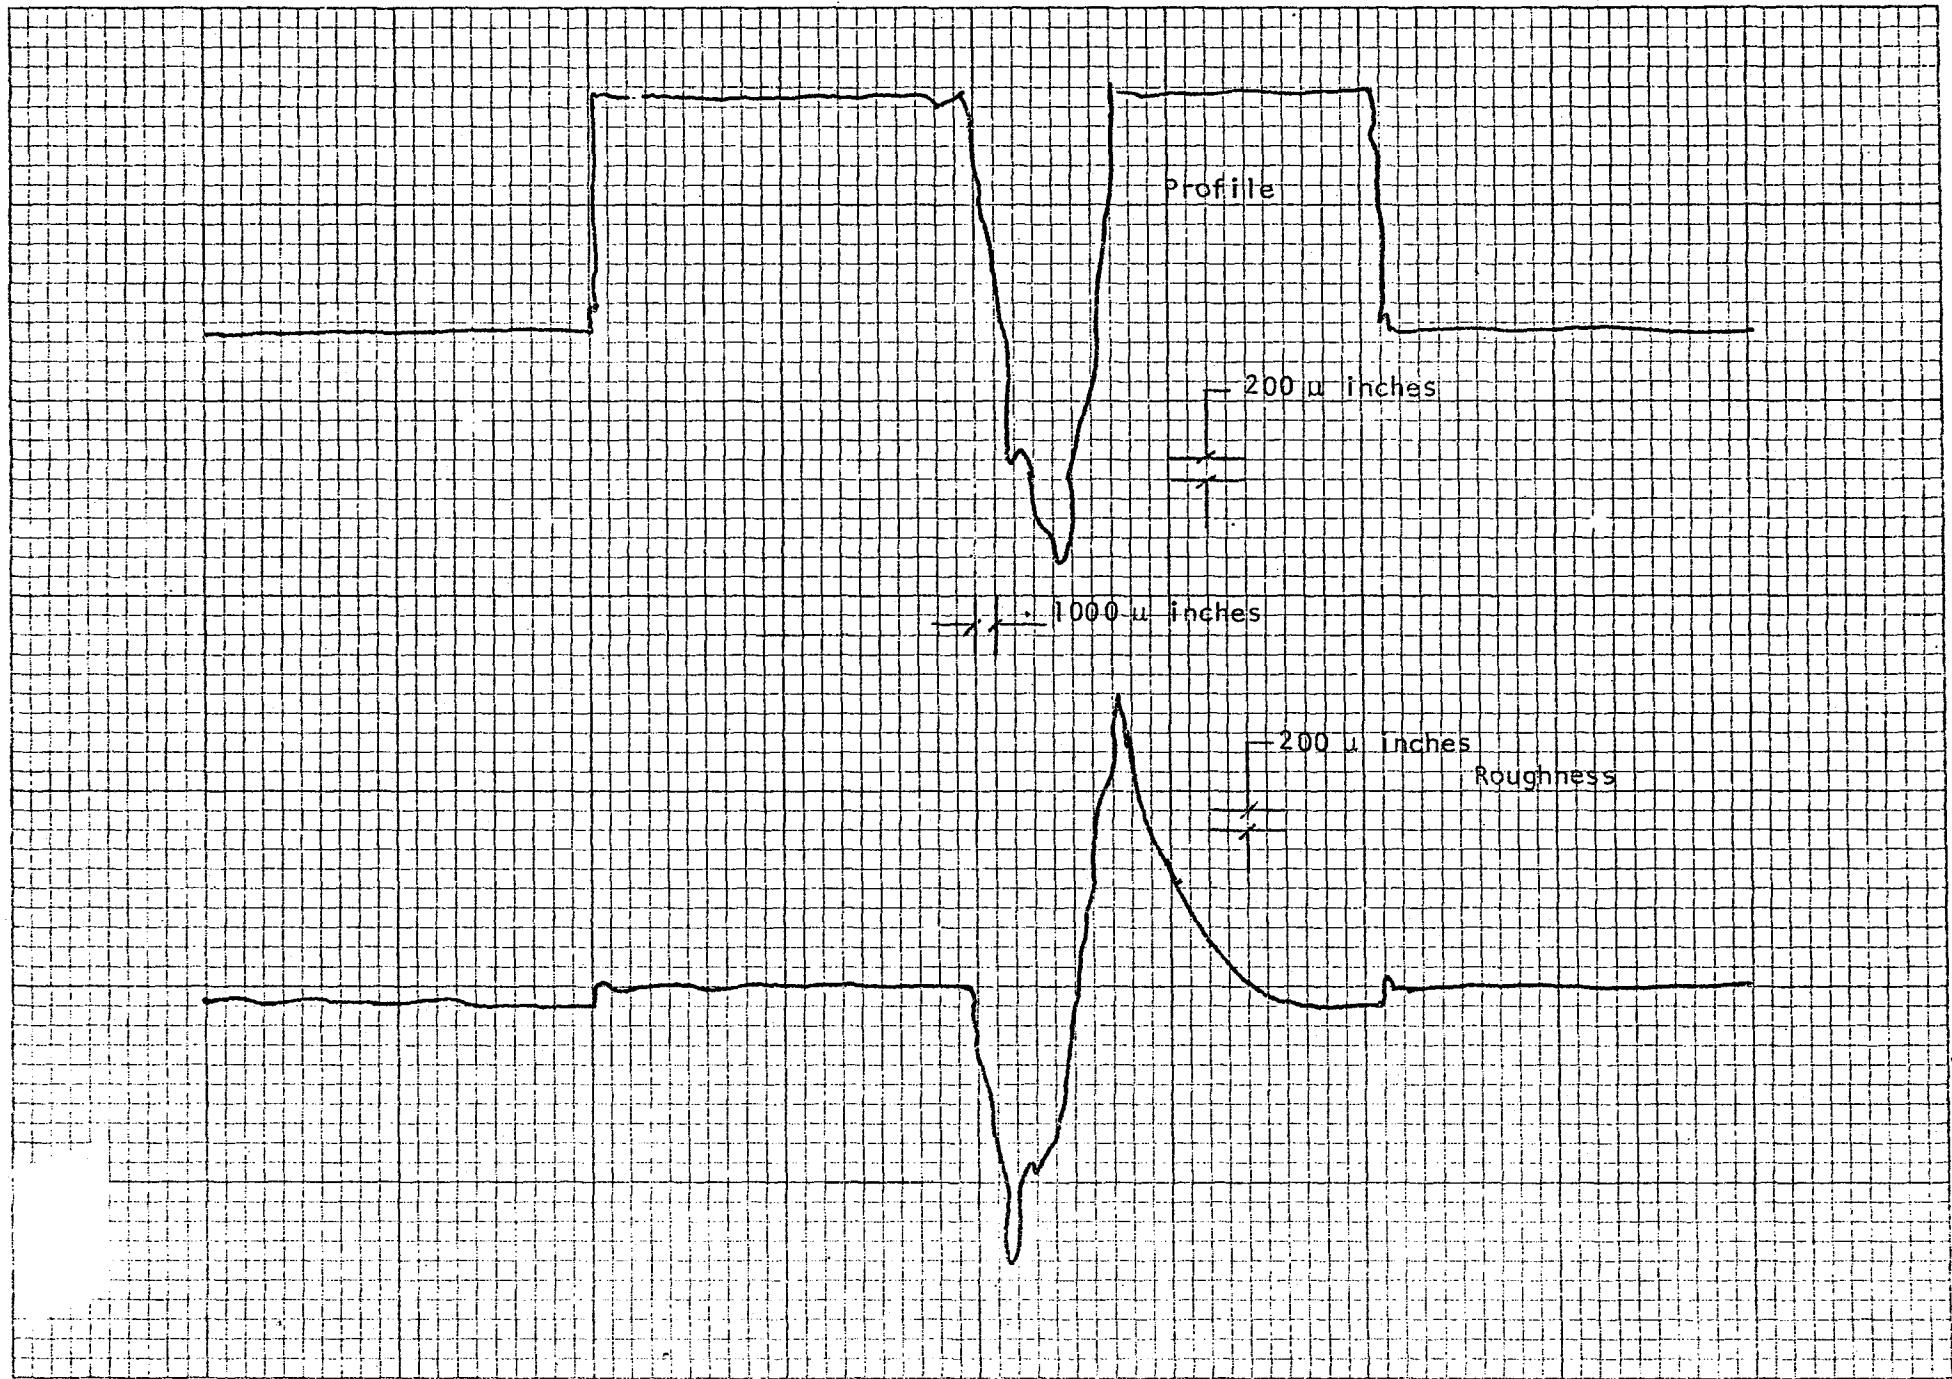
Figure 3-2b - Profilometer measurement of the fault eloxed into the inner race of bearing S/N 4.

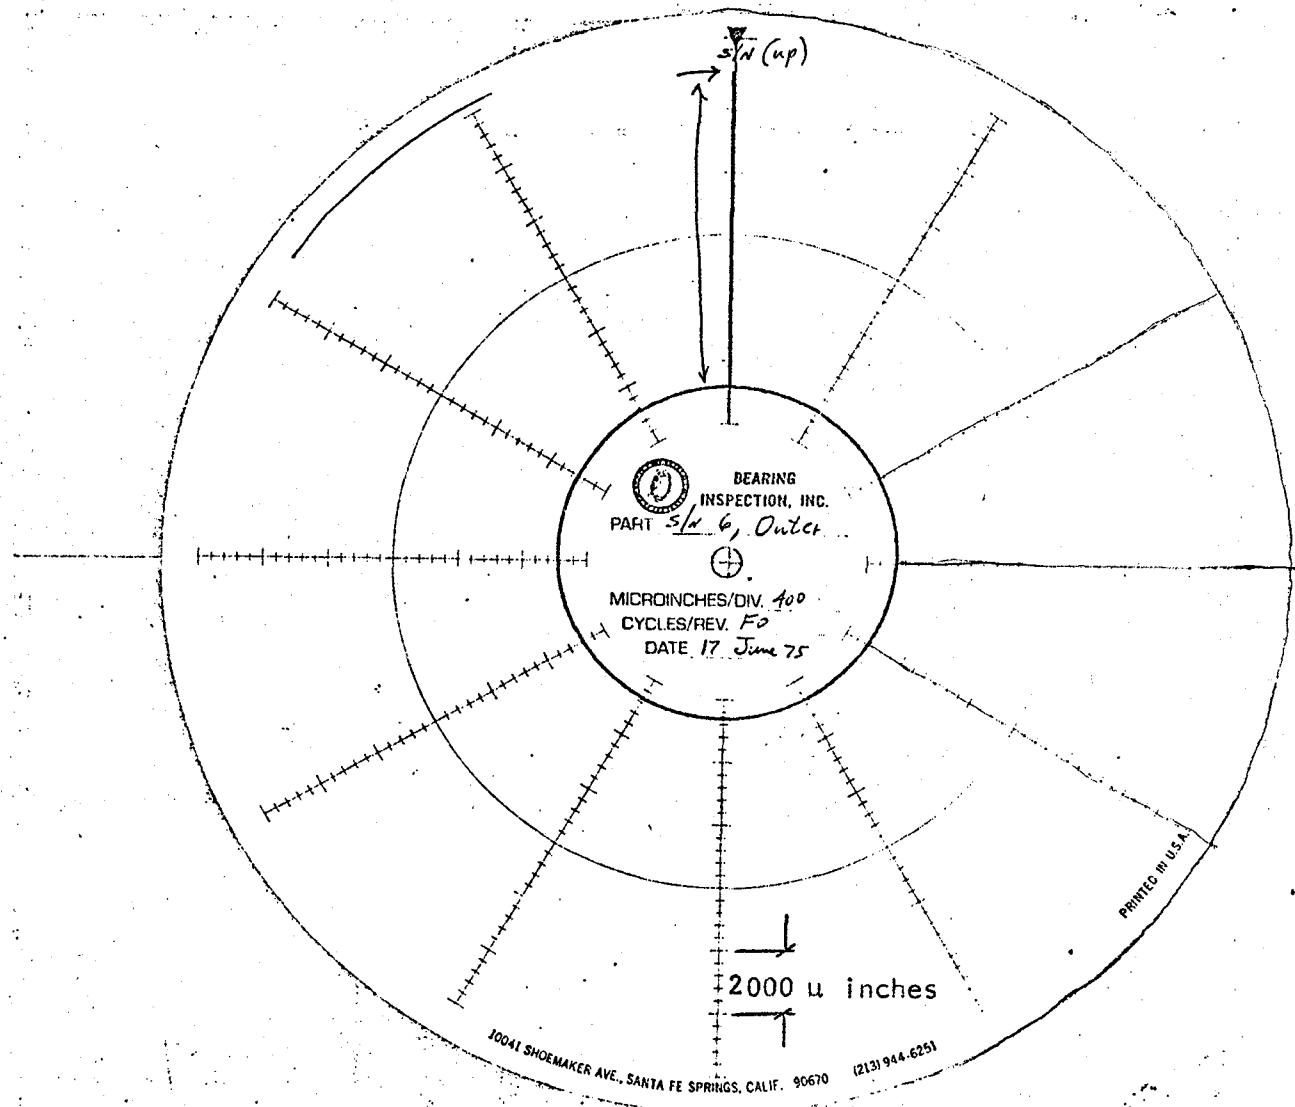
Figure 3-3a. - Profilometer measurements of the fault location eloxed into the outer race of bearing S/N 6.

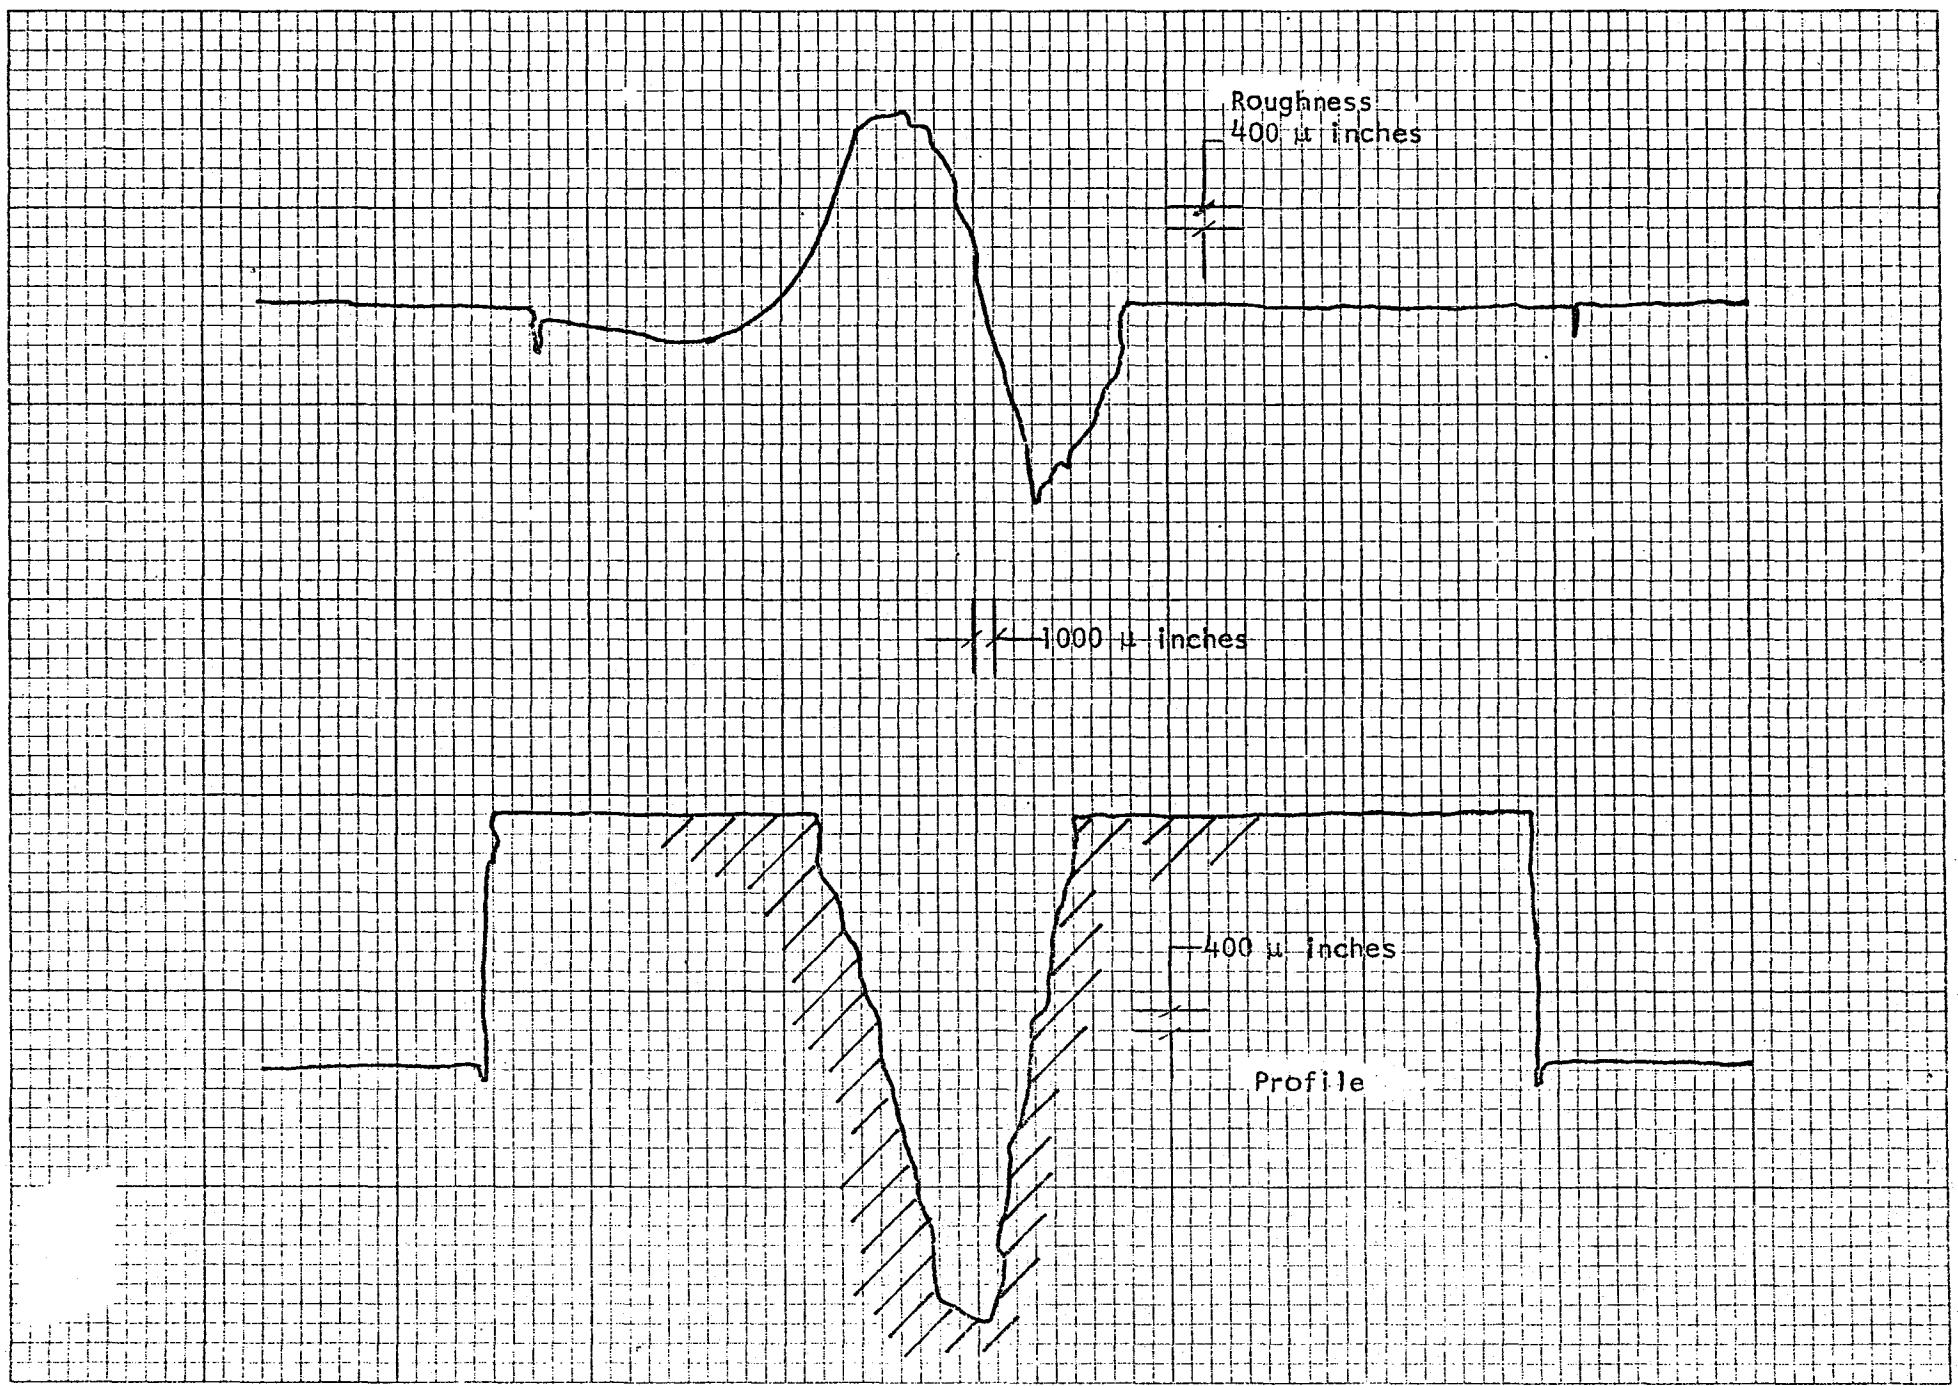
Figure 3-3b - Profilometer measurement of the fault eloxed into the outer race of bearing S/N 6.

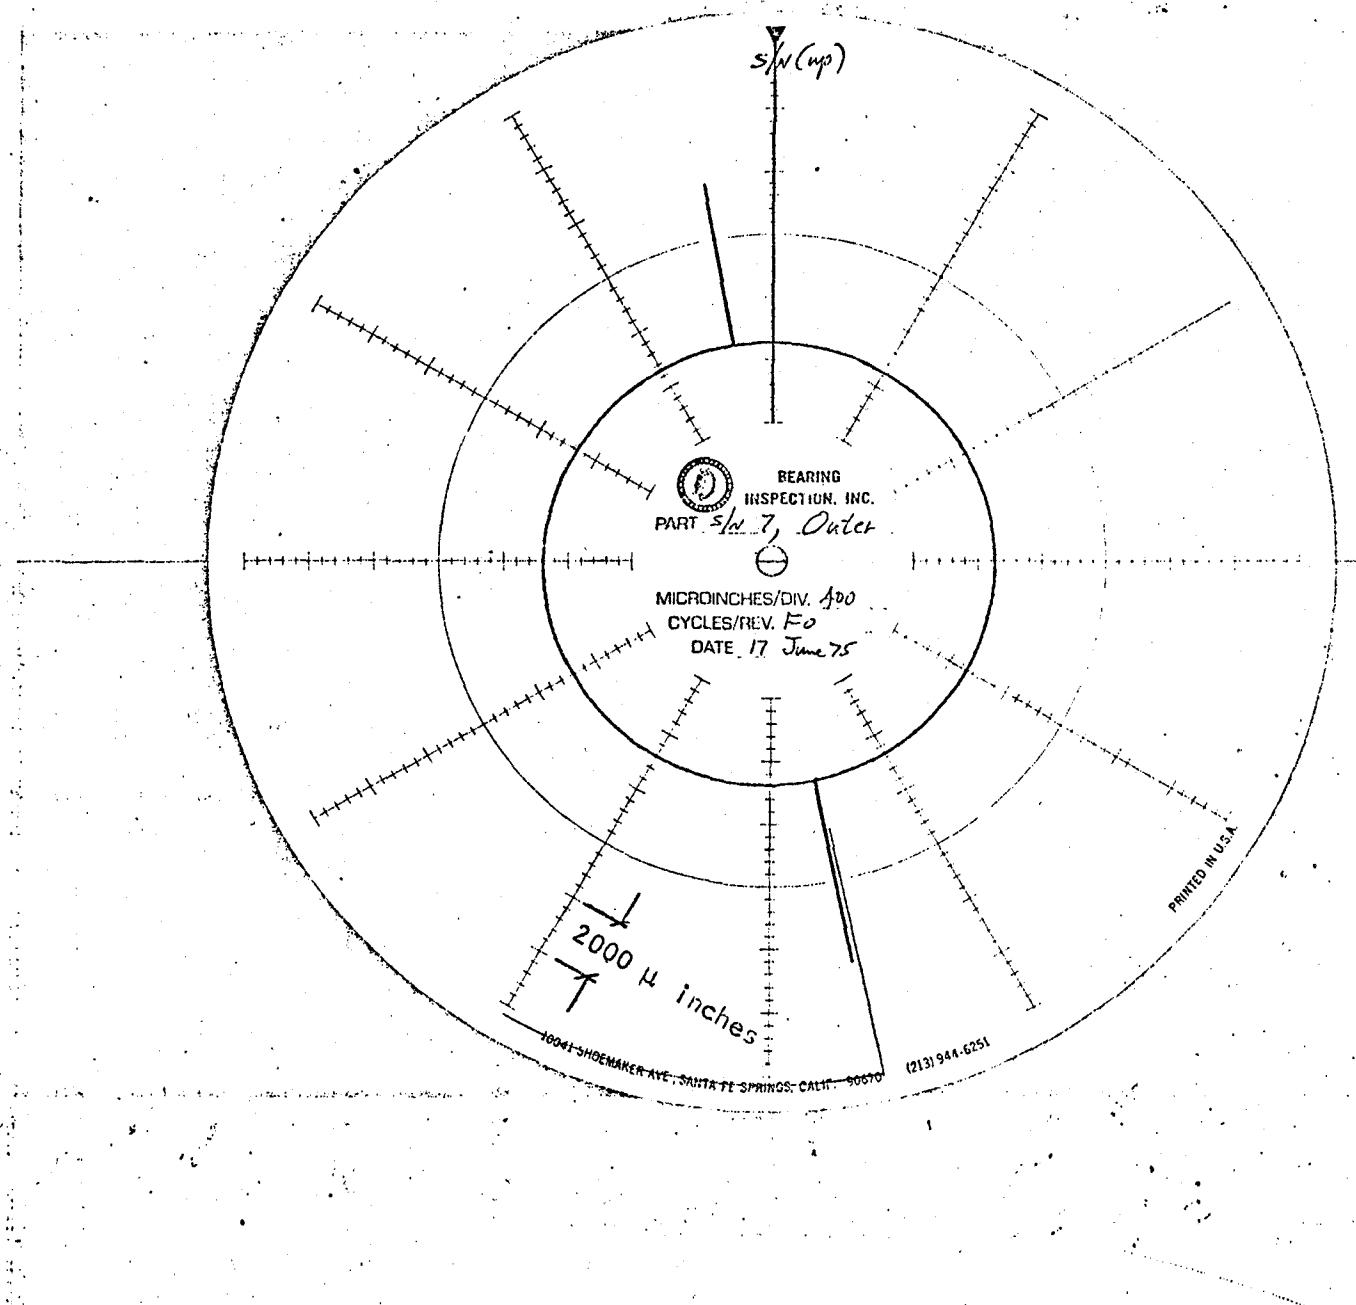
Figure 3-4a - Profilometer measurement of the fault locations etched into the outer race of bearing S/N 7.

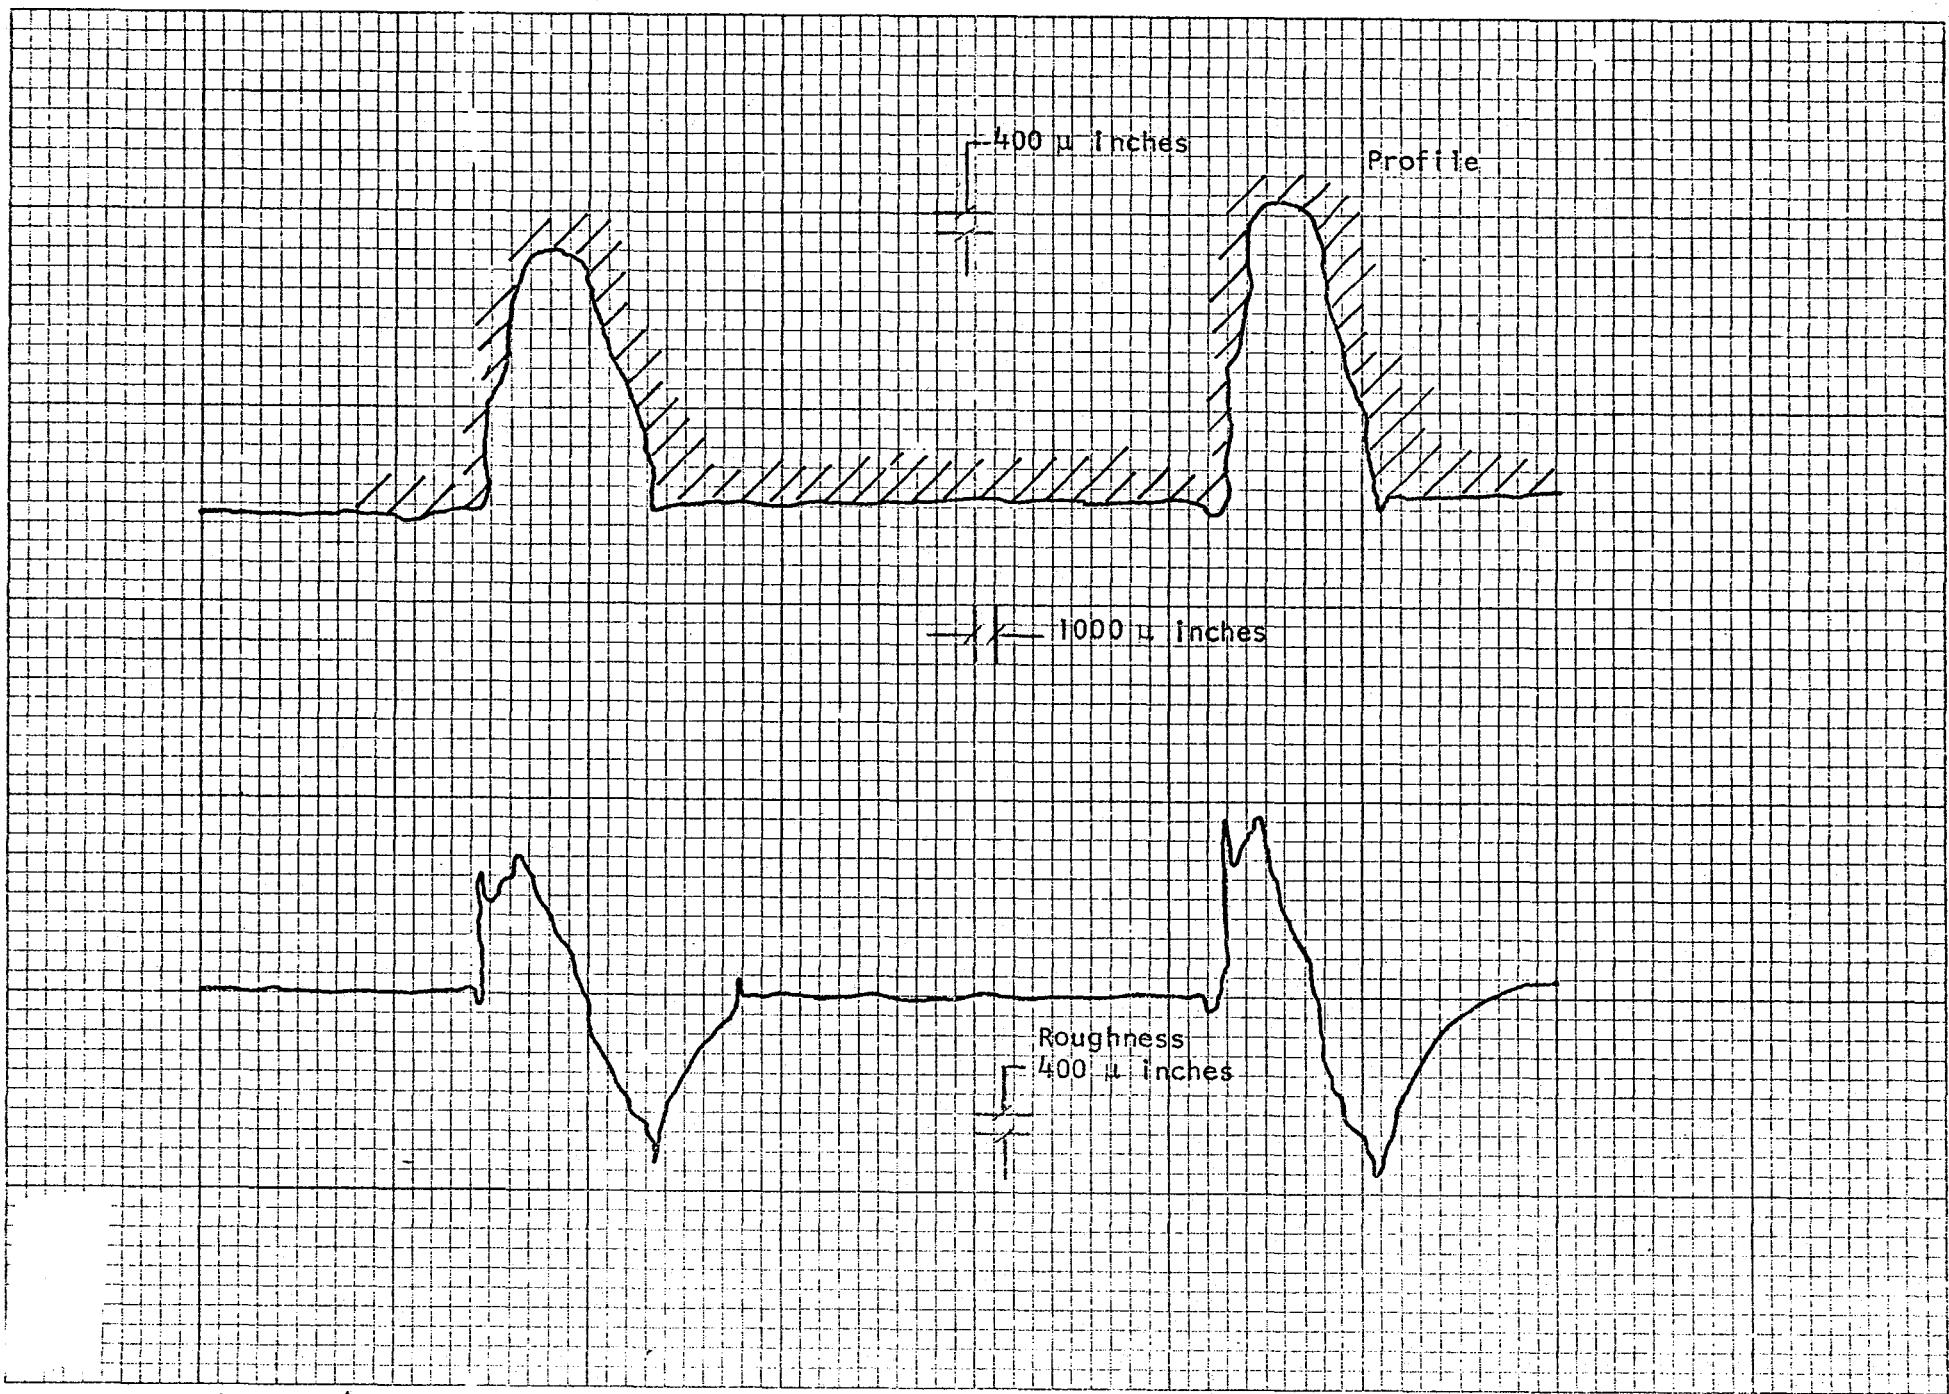
Figure 3-4b - Profilometer measurement of the faults eloxed into the outer race of bearing S/N 7.

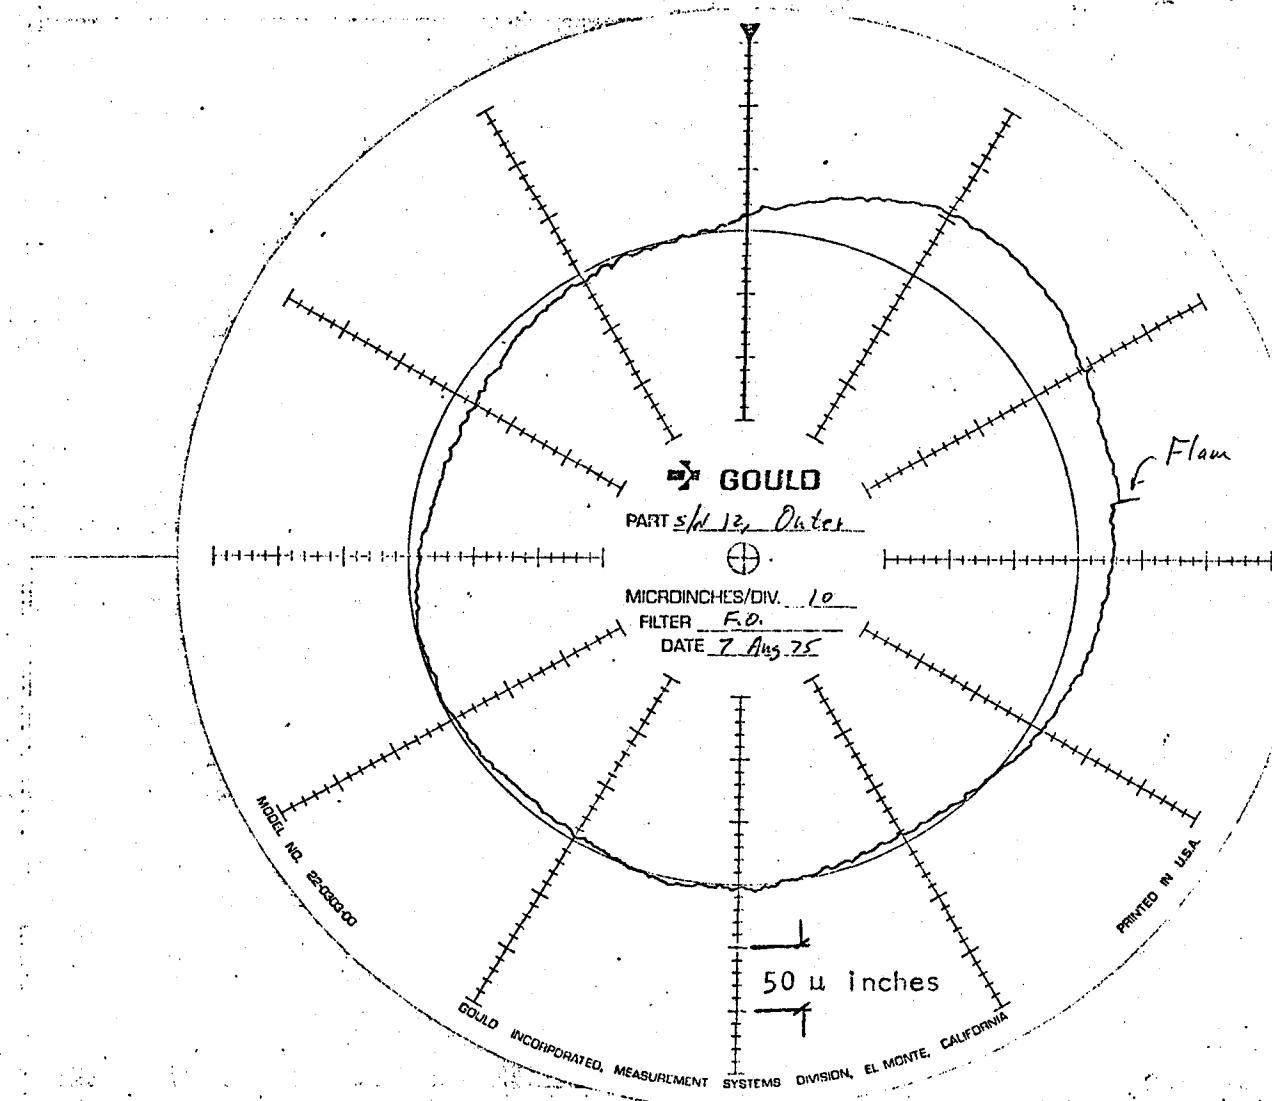
Figure 3-5a - Profilometer measurement of the fault location scribed into the outer race of bearing number 12.

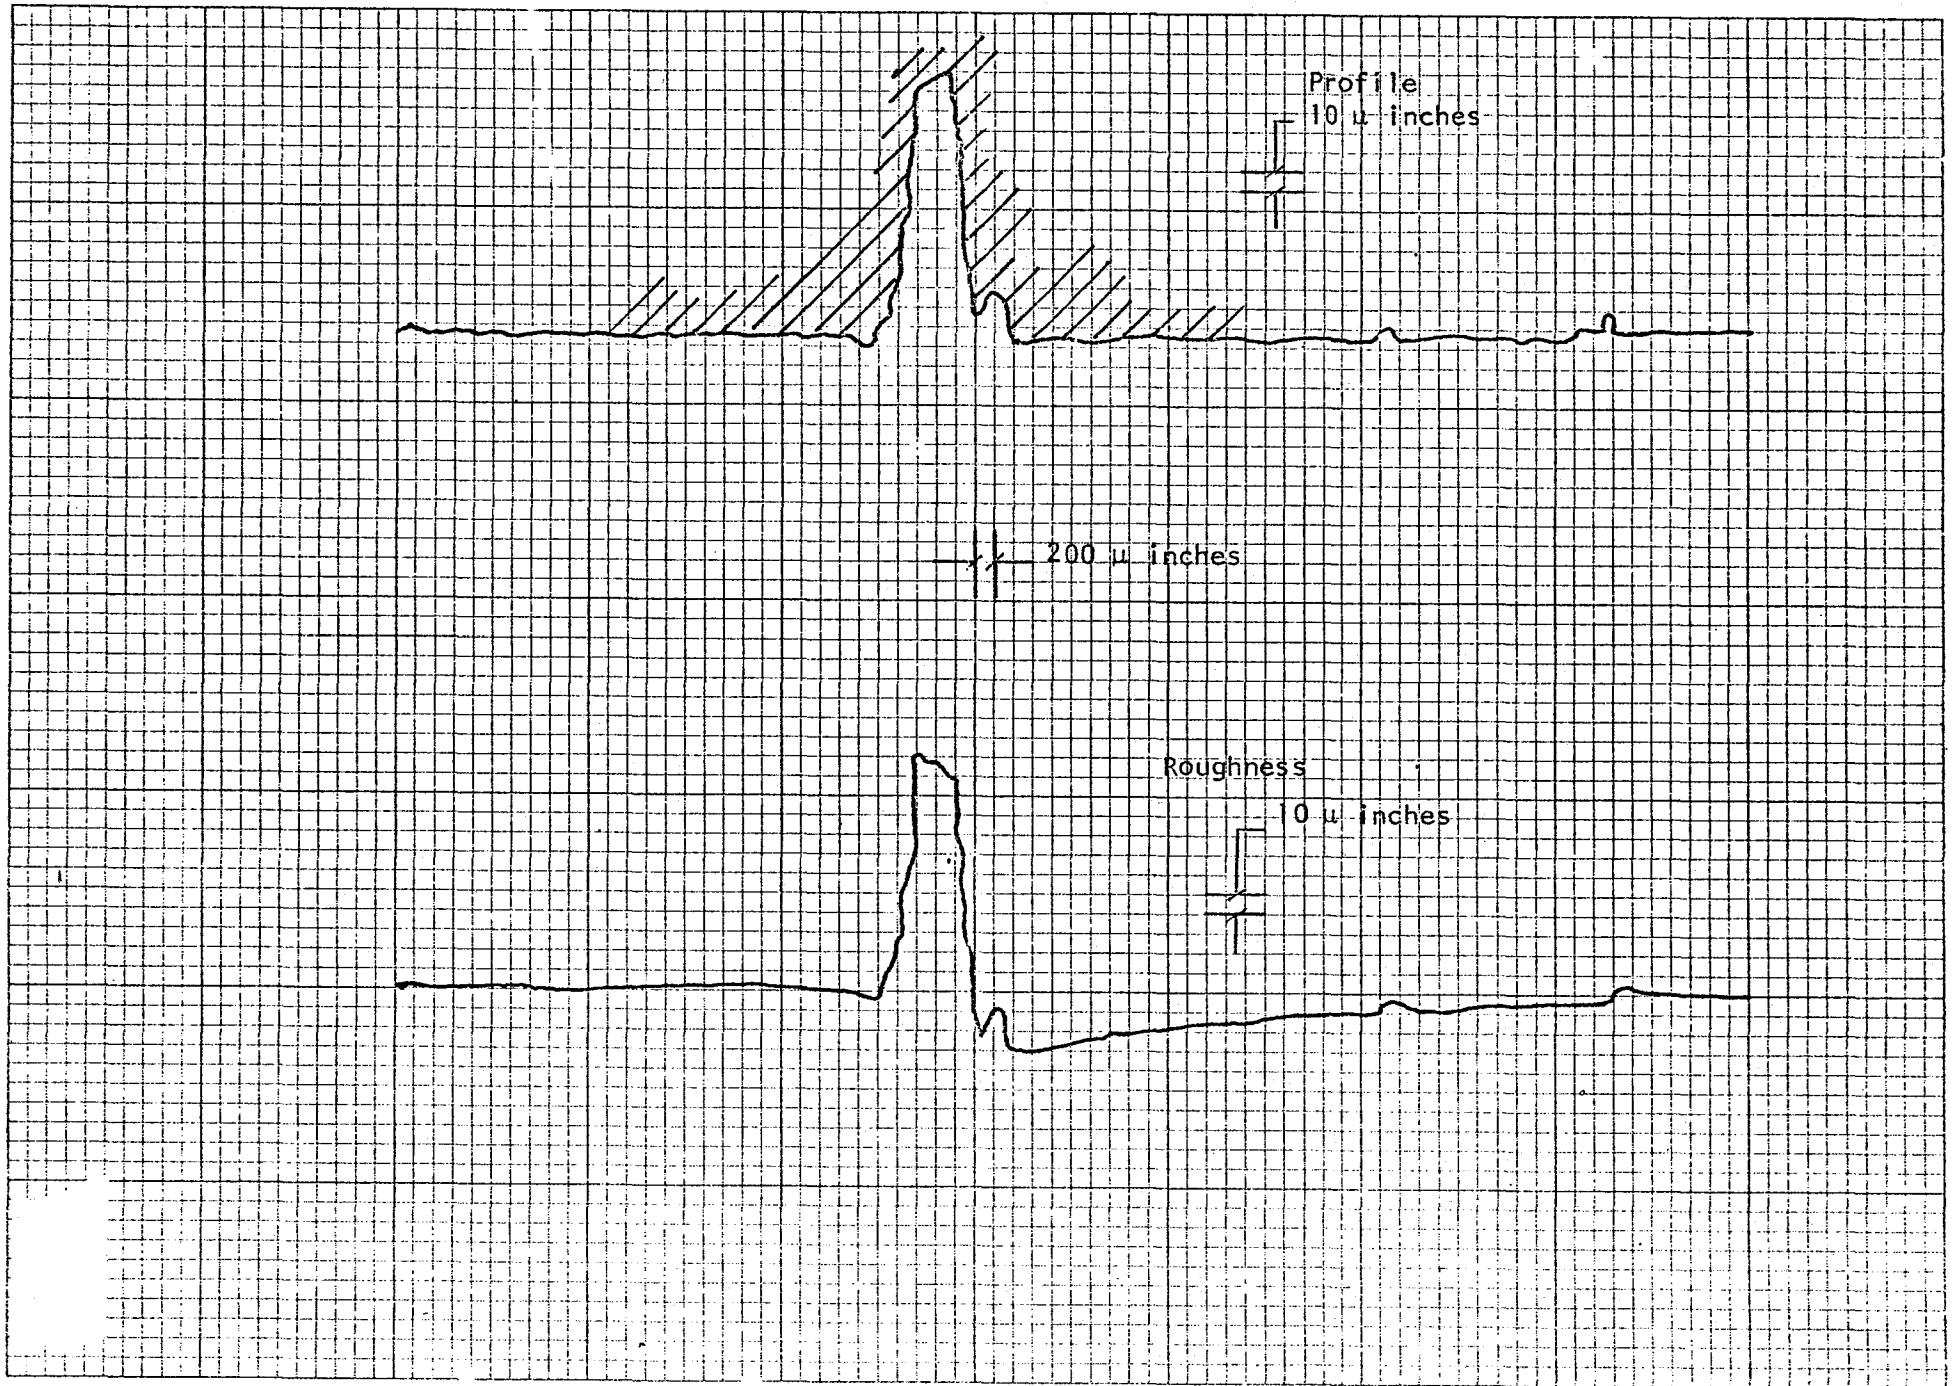
Figure 3-5b - Profilometer measurement of the fault scribed into the outer race of bearing S/N 12.
